Manhole Inspection Summary

Manhole # S15MM1003MH

Insp Date: **6/19/07 10:19 AM**

Location Address: **GREENSPRING AVE**

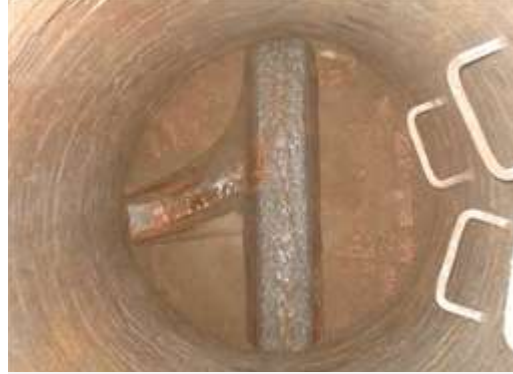
Top View

Infiltration: ☐ None ☒ **Joint** ☐ Cracks ☐ Mortar ☐ Roots ☐ Wall

Adjustment infiltration. Bench and Channel debris.

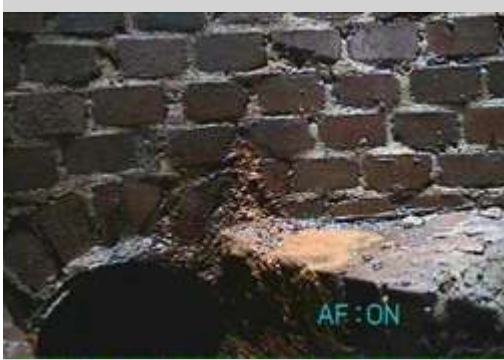
Defect

Condition: ☐ Sound ☐ Cracked ☐ Root Intrusion ☐ Loose Brick ☒ **Deteriorated**

Infiltration: ☐ None ☐ Joint ☐ Cracks ☒ **Mortar** ☐ Roots ☐ Wall

Barrel deterioration and infiltration.

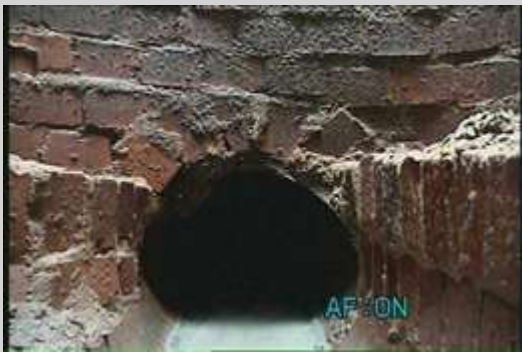
12 in. Circular Gravity Sewer Pipe Out @ 12 O'Clock

Infiltration: **Evidence** Pipe Seal Cond: **Broken**

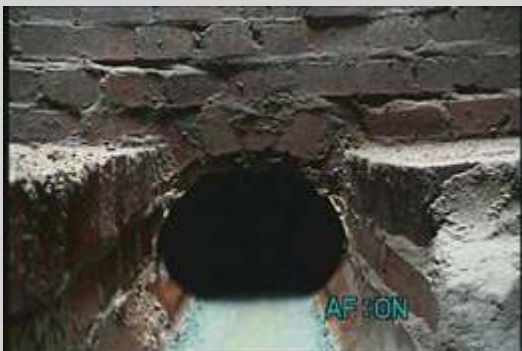
12 in. Circular Gravity Sewer Pipe In @ 6 O'Clock

Barrel deterioration and infiltration.

Infiltration: **Evidence** Pipe Seal Cond: **Cracked**

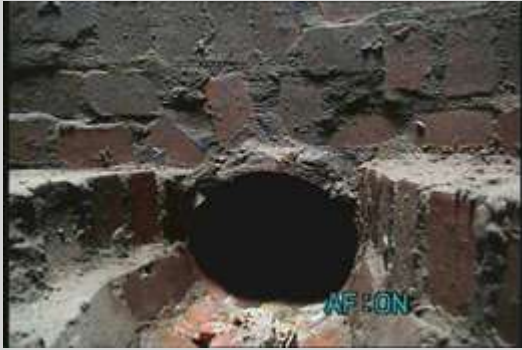
8 in. Circular Gravity Sewer

Deposits: ☐ None ☐ Mud ☐ Sludge ☒ **Debris** ☐ Grease

Deposits Extent: **Light**

Infiltration: **Evidence**

Pipe Seal Cond: **Broken**
